Use of image analysis to evaluate surface dispersion and covering performance of nanolime coatings sprayed on heritage material substrates

Use of image analysis to evaluate surface dispersion and covering performance of nanolime coatings sprayed on heritage material substrates.

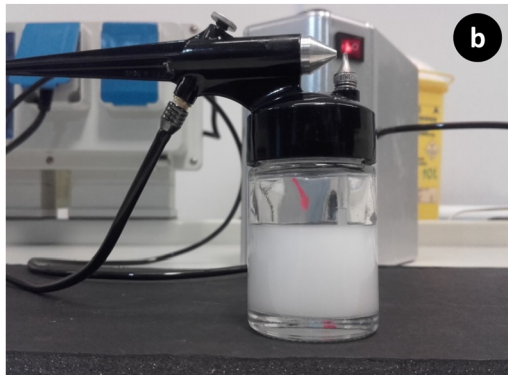
Figure 1

Fig. 1 a) Glass reactor and modified atmosphere to avoid carbonation; b) compressor and laboratory nebuliser containing nanoparticles in 2-propanol (5 g/L)

Pure Ca(OH)_2 -NP were synthesised in a glass reactor under N_2 atmosphere to prevent carbonation to happen (Fig. 1a). The reaction was carried out using analytical grade reagents and the purification of the solid phase was carried out as recently described by Madrid and Lanzón [17]:

Scanning Electron Microscopy (SEM) was used to assess the thickness of nanoparticle-based Ca(OH)_2 coatings sprayed on flat surfaces (control). The control surface consisted of 40x40 mm black cellulose substrates on which the treatment was repeatedly sprayed. The coating was applied at a uniform distance of 10 cm in five consecutive layers with a laboratory nebuliser (Fig. 1b). Once coated, the control surfaces were metallised with Au (25 nm coating)

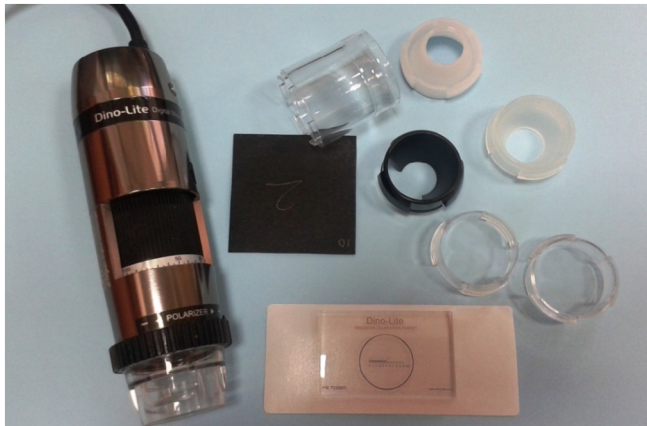
Figure 2

Fig. 2. Digital microscope for surface examination. Accessories, calibration device and example of 40x40 mm control surface.

A Digital Microscopy (Dino-Lite Edge) for surface examination was used to characterise the coatings deposited on the surface. The microscope was equipped with Dino-Capture 2.0 software, polariser filter and a measurement device that allows precise quantification of distances at the selected magnification (Fig. 2). A set of adjustable LEDs allowed adjustment of light intensity and hence, the acquisition of comparable images with the microscope. The images were captured at the same magnification (65x), saved as .tiff files and opened with ImageJ software.

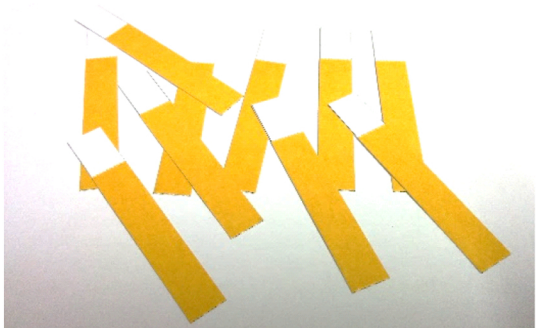
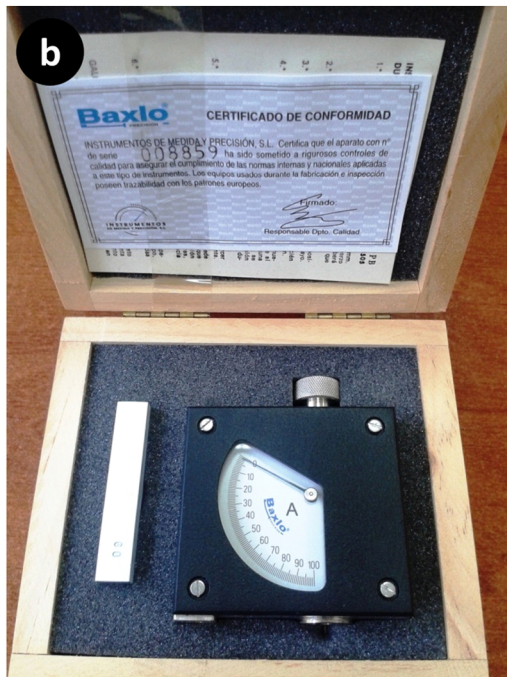
Figure 3

Fig. 3 Test for measuring the physical resistance of materials at the surface: a) adhesive strips for peeling tests; b) Shore-A durometer for soft materials.

The surface cohesion of treated and non-treated samples was studied by means of non-destructive methods like peeling tests and hardness (Fig. 3). The peeling test was carried out with 10 x 50 mm adhesive strips on the external surface of laboratory-made plasters (Fig. 3.a). The material adhered to the tape was weighed with a resolution of $\pm 0.0001\text{g}$ [8]. The measurements were repeated 10 times to calculate the average amount of material bonded to the strip (removed) as well as the relative standard deviation (RSD %).

The study of consolidation was completed with a Baxlo[®] durometer suitable for soft materials (Fig. 3b). The durometer uses a truncated cone indenter to create small indentations on the surface. The hardness was measured 10 times per sample and a standard material (60 Shore-A units) was used as reference.
